Manhole Inspection Summary

Manhole # S13MM_047MH

Insp Date: **3/24/08 2:07 PM**

Location Address: **2212 KOKO LN**

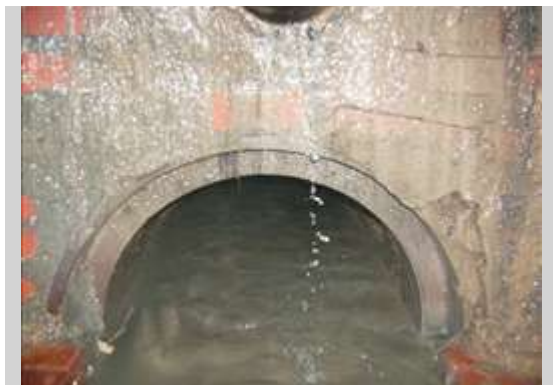
12 O'Clock Outflow

24 in. Circular Gravity Sewer
Pipe Out @ 12 O'Clock

Invert Depth: **29.72** (ft.) Flow Characteristics: **Fast**

Deposits: ☒ None ☐ Mud ☐ Sludge ☐ Debris ☐ Grease

Infiltration: **None** Pipe Seal Cond: **Sound**

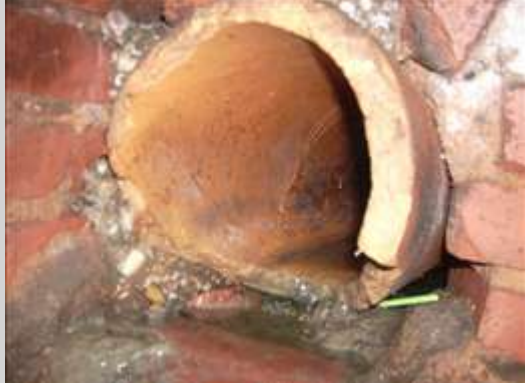
3 O'Clock Inflow

8 in. Circular Gravity Sewer

Pipe In @ 3 O'Clock

Invert Depth: **27.08** (ft.) Flow Characteristics: **None**

Infiltration: **None** Pipe Seal Cond: **Sound**

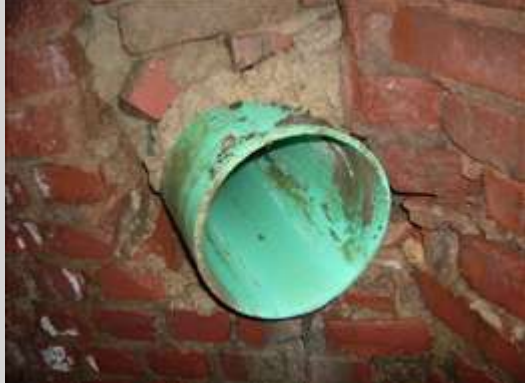
9 O'Clock Inflow

8 in. Circular Gravity Sewer

Pipe In @ 9 O'Clock

Pipe Material: **PVC** ☐ Pipe Lined

Infiltration: **None** Pipe Seal Cond: **Sound**
